# Wapiti Fire Burned Area Summary

## 2500-8 Burned Area Report

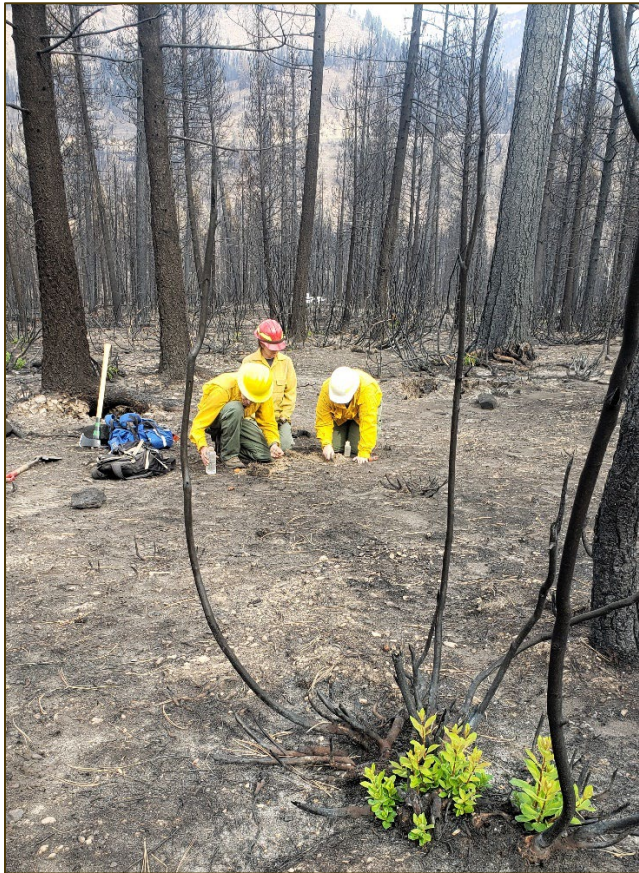
Figure 2 Scientists spent multiple days making ground observations about soil conditions.

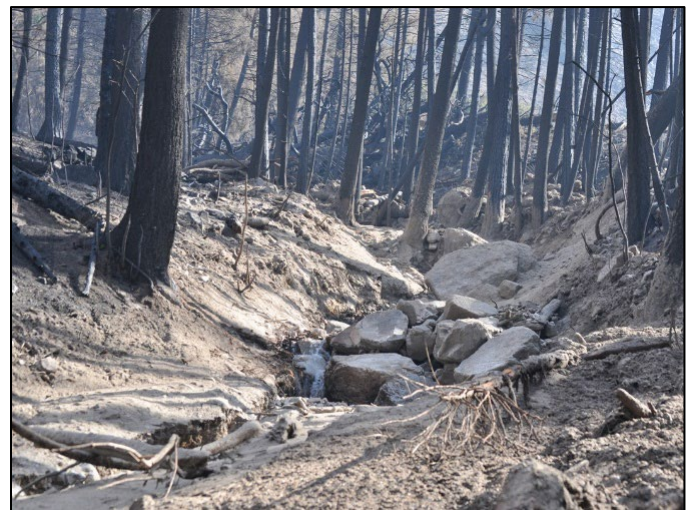
Figure 3 The Grandjean area has already experienced multiple debris flows.

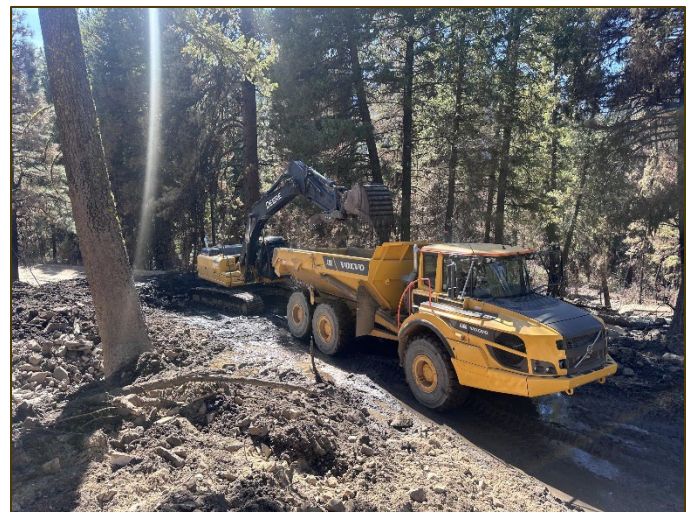
Figure 4 Debris flows from mid-September rains already impacted the Grandjean Road, causing fire crews to use heavy machinery to open the road for fire crews.

State Highway 21 is a heavily used road but is kept clear and open by the Idaho Transportation Department road crew. Critical engineering values addressed in the BAER report include Forest Service System Roads and related drainage features. Treatments for the protection of these roads include road drainage storm proofing (clearing debris in drainage features before approaching storms), storm inspection and response (inspecting drainage features after storms to ensure proper operation), warning signs, and gate closures.

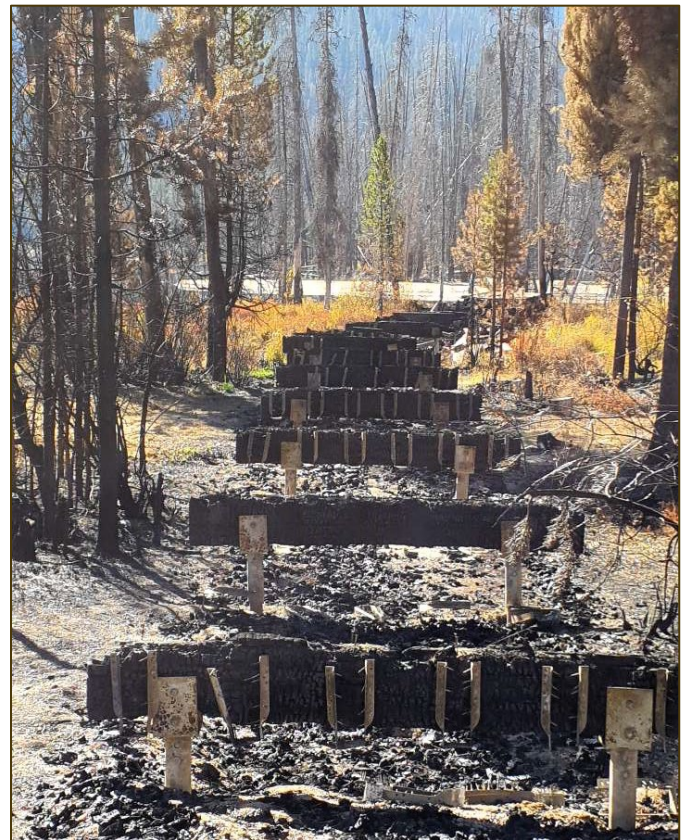
Figure 5 This popular boardwalk at Stanley Lake was destroyed.

The team proposes trail drainage stabilization treatments, which include armoring and/or cleaning existing water control features such as water bars and adding additional drainage features to provide additional capacity for elevated sediment laden post-fire runoff.

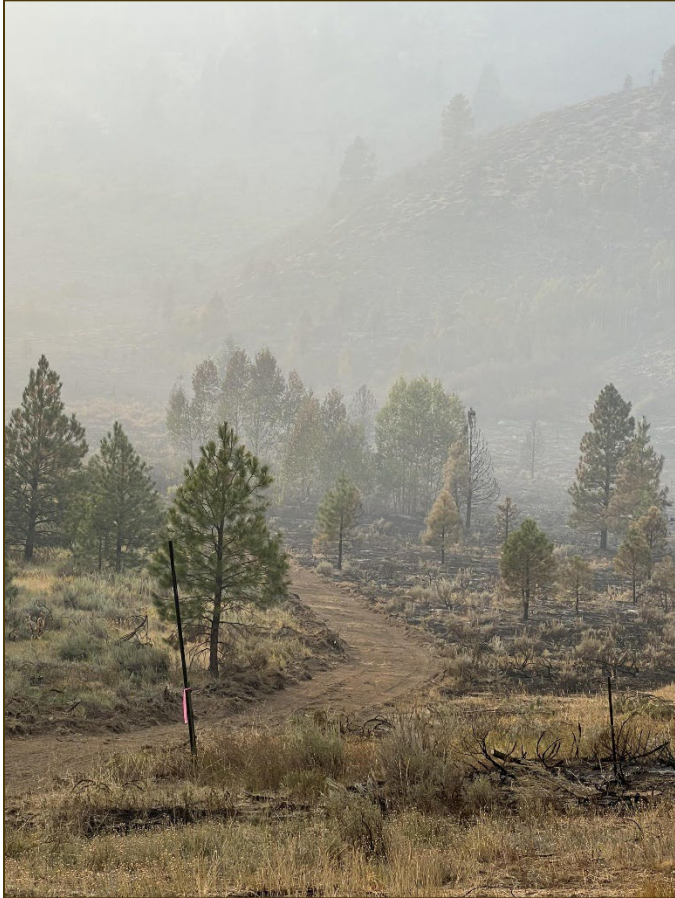
Figure 6 Dozer suppression lines are hot spots for invasive weeds.

plants. Spread of invasive plants into un-infested areas due to conditions created by the fire pose direct competition for resources including water, nutrients, and above and underground growing space. BAER treatments include the survey, treatment, and monitoring of invasive species infestation in 183 acres of at-risk land.
